DOT/FAA/CT-94/119

Evaluation of Alternative Pavement Marking Materials

January 1995

Final Report

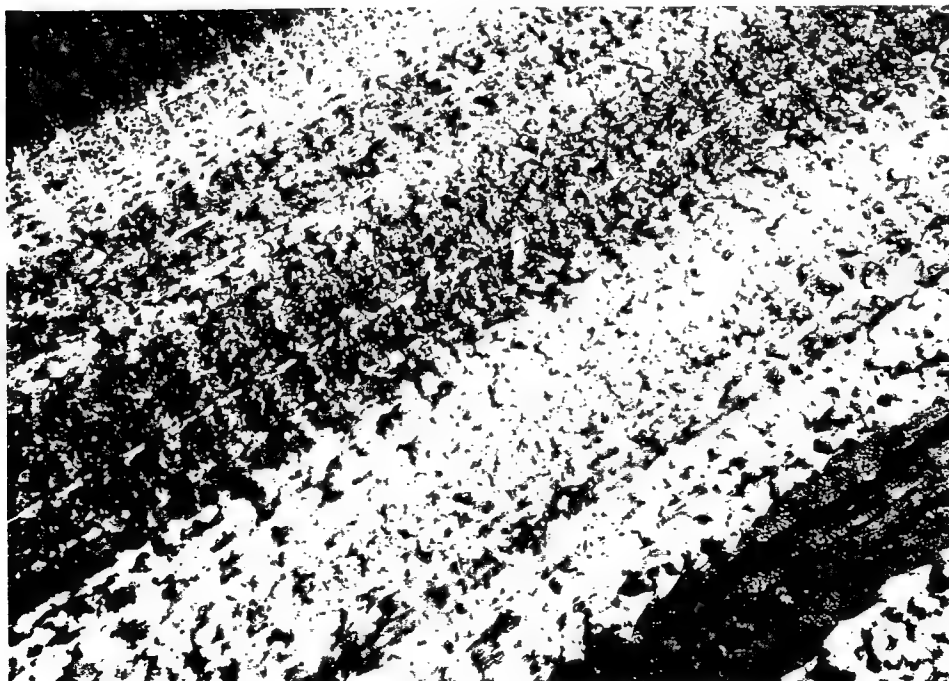
Resistance to rubber buildup is an important factor on those materials which have been installed in an area subjected to the impact of aircraft landing gear. At the Atlantic City location, the water-borne material no. 1 was almost totally covered with rubber within a short time after application. Each of the other materials had significantly less rubber coverage at this site. Certain materials offered greater rubber resistance than others. Resistance to rubber buildup was better when silica and/or bead additives were applied to the material, as opposed to the heavier buildup noted with similar materials not having silica or beads applied.

FIGURE A-19. RUBBER BUILDUP ON RUNWAY TEST STRIPE

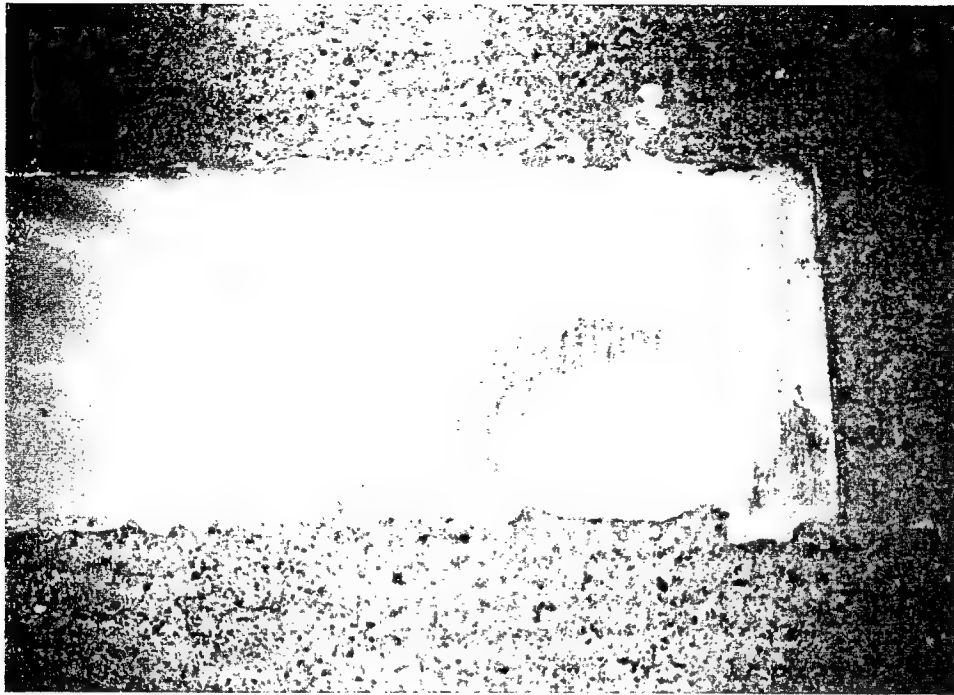
A harsh winter environment caused significant damage to all but the most durable materials. A number of snowfalls were experienced at the Pittsburgh and Atlantic City airports exposing the materials to snow removal operations. In Pittsburgh a significant amount of damage from snow plowing was experienced on the materials applied to the concrete taxiway surfaces. The use

FIGURE A-20. SNOWPLOW STRIKE ON METHACRYLIC RESIN

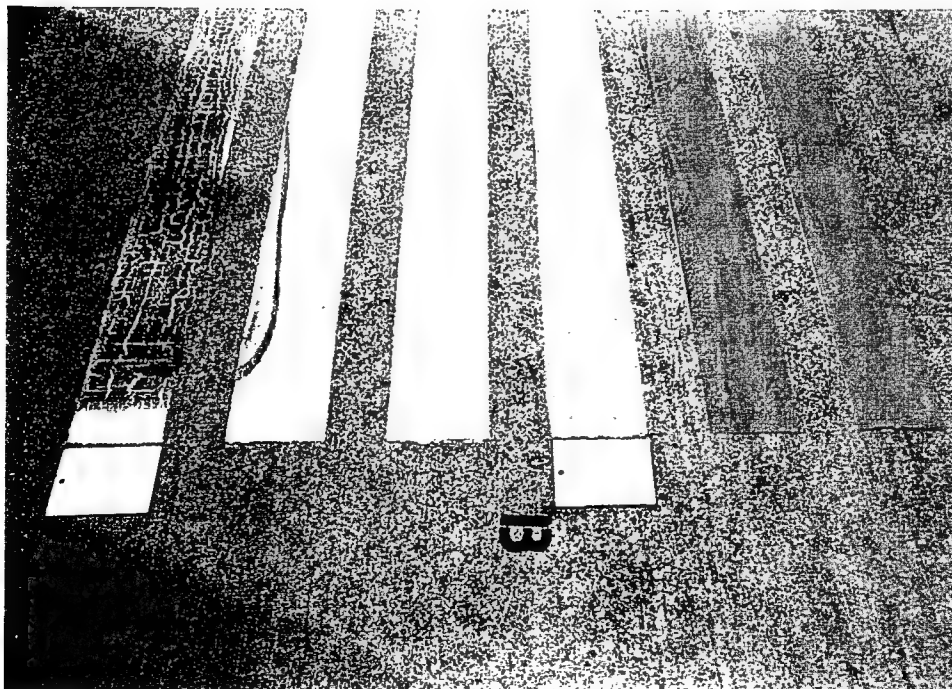
The taxiways Bravo and Hotel test stripes were each inspected on a monthly basis. One stripe of epoxy material (Epoxy no. 2, white, non-beaded) was noted to have not completely cured and assumed a blackened appearance. The blackened appearance was a result of the partially cured epoxy collecting the dirt from the main gear of the aircraft and vehicle tires as they passed over the test stripe. One benefit to be mentioned is that the material remained in place even though only partially cured. The test stripe did not delaminate from the concrete surface therefore eliminating the potential for foreign object damage (FOD).

FIGURE A-21. EPOXY NO. 2 - INCOMPLETE HARDENING

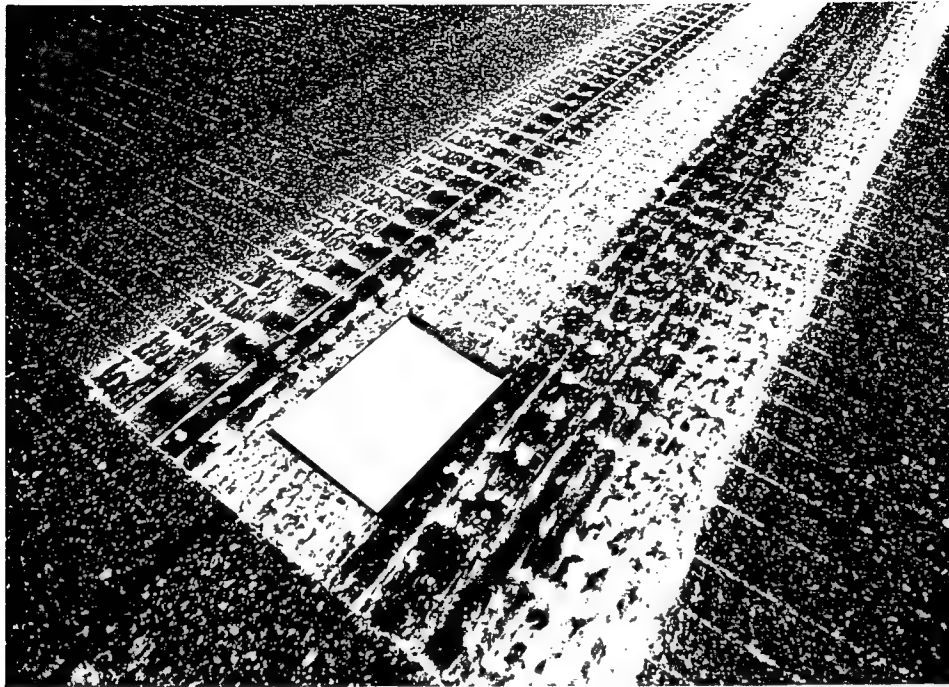
FIGURE A-22. RUBBER ACCUMULATION ON RUNWAY TEST STRIPE

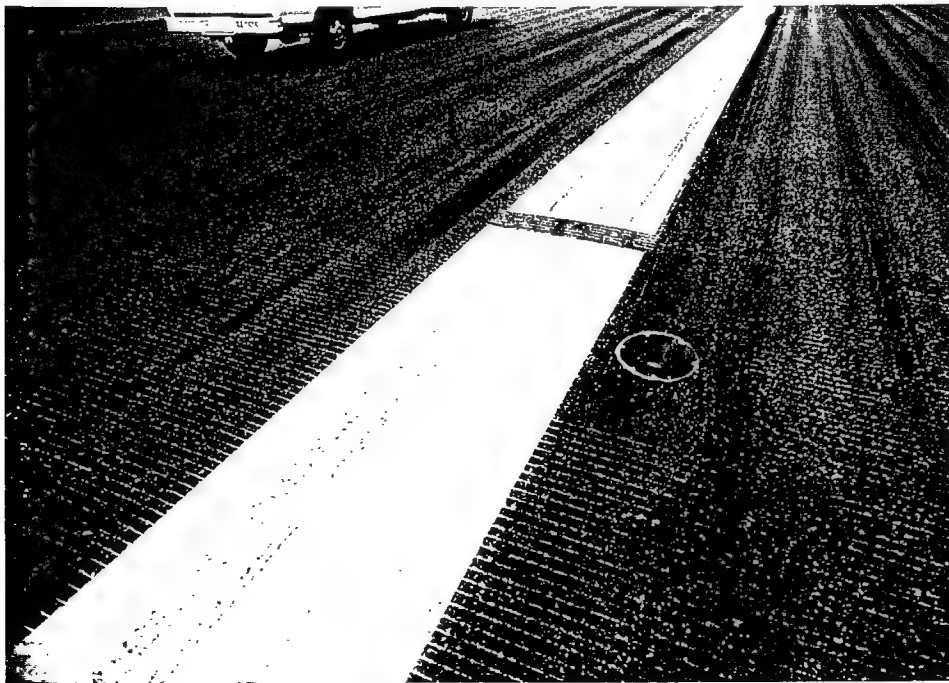
FIGURE A-23. COLOR VARIANCE - ATLANTIC CITY

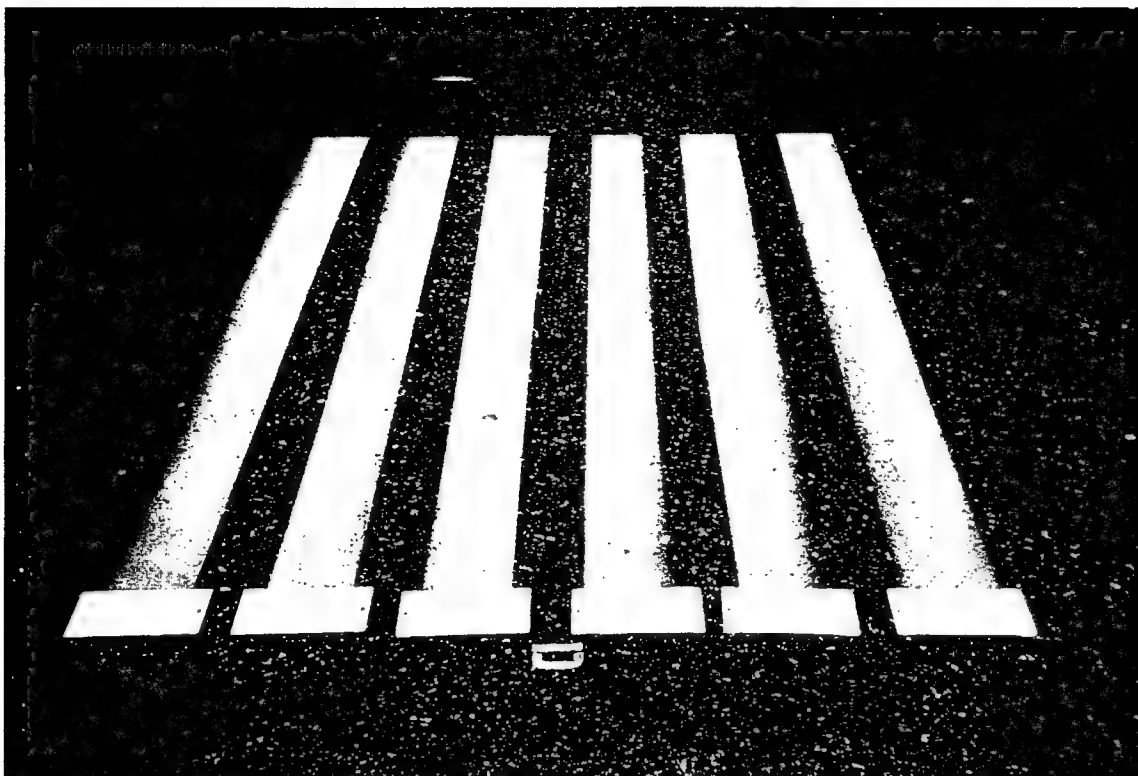
At Atlantic City airport the water-borne material no. 2 was found to have developed a rust-colored cast on the runway threshold stripes and on the asphalt taxiway stripes. Since this occurred only on the asphalt pavement surfaces, it was believed that a component in the asphalt mix was interacting with the materials. Use of drawdowns and comparative photographs illustrated the color transformations that occurred. Refer to the appendix for individual comparisons. Overall, the test materials displayed a constancy in color characteristics with the exceptions already noted.

FIGURE A-24. WATER-BORNE DISCOLORATION - ASPHALT SURFACE

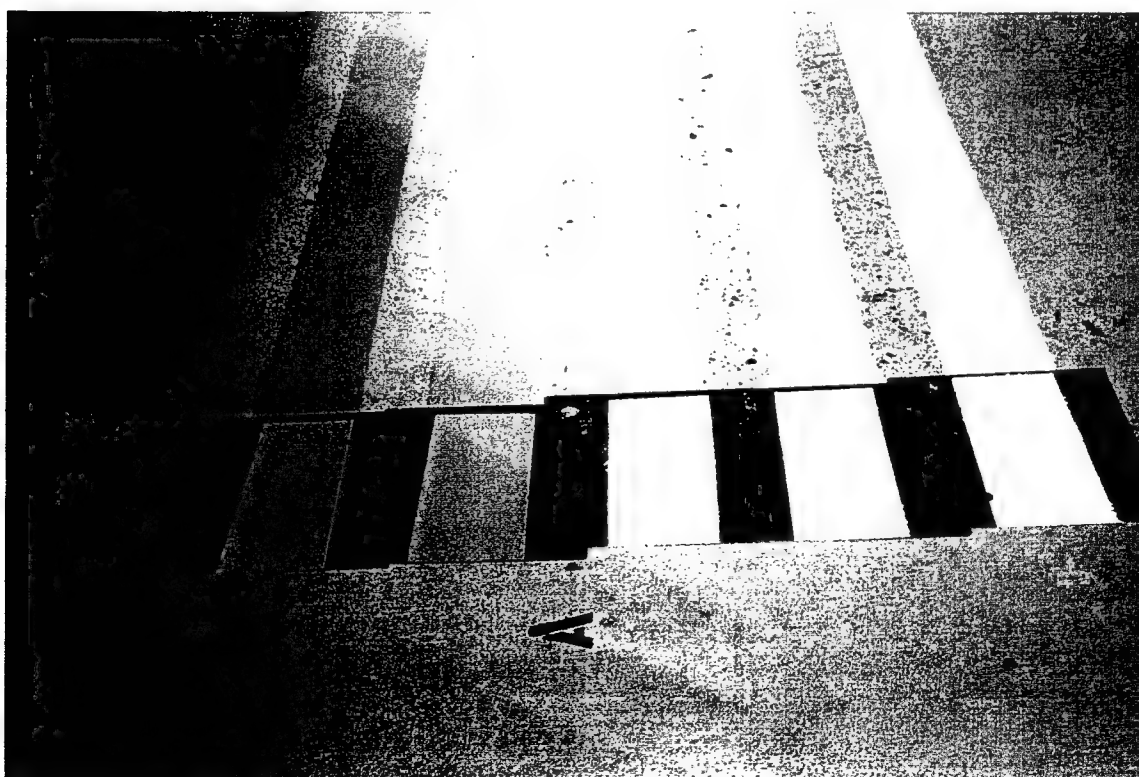
FIGURE A-25. EPOXY NO. 1 DISCOLORATION - CONCRETE SURFACE

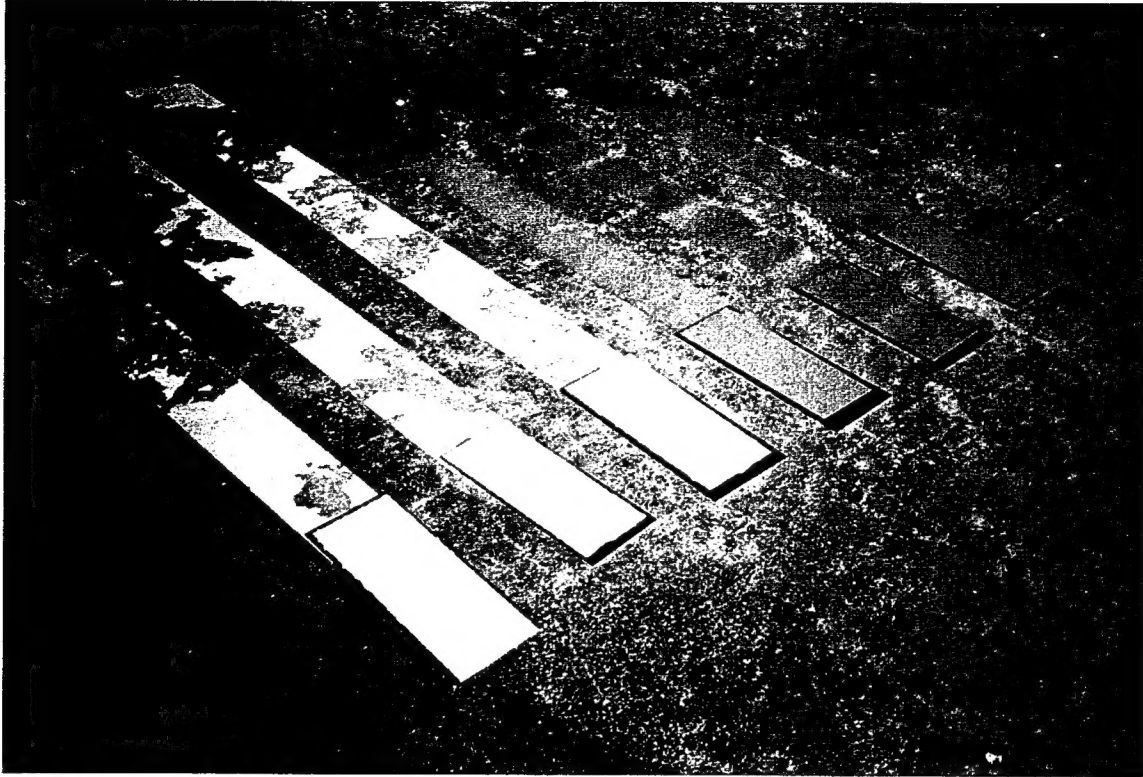
FIGURE A-28. EPOXY NO. 1 TAXIWAY TEST STRIPE AFTER 1 YEAR - PITTSBURGH

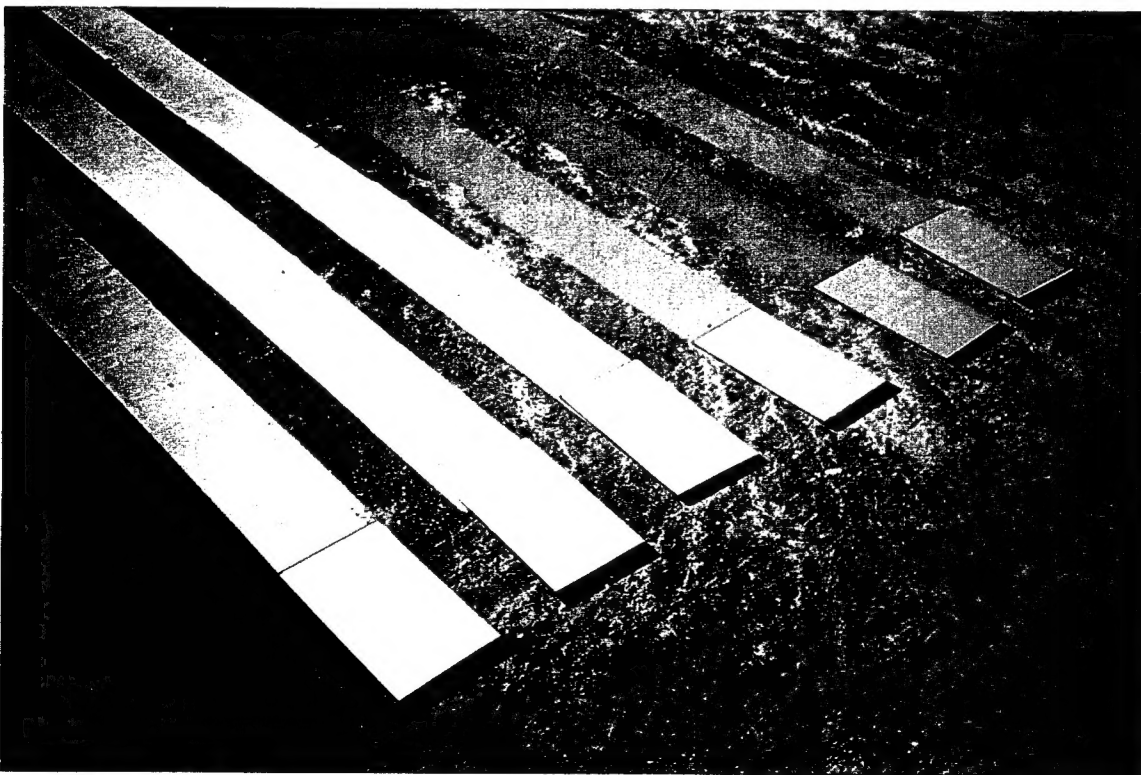
FIGURE A-29. EPOXY NO. 2 TAXIWAY TEST STRIPE AFTER 1 YEAR - PITTSBURGH

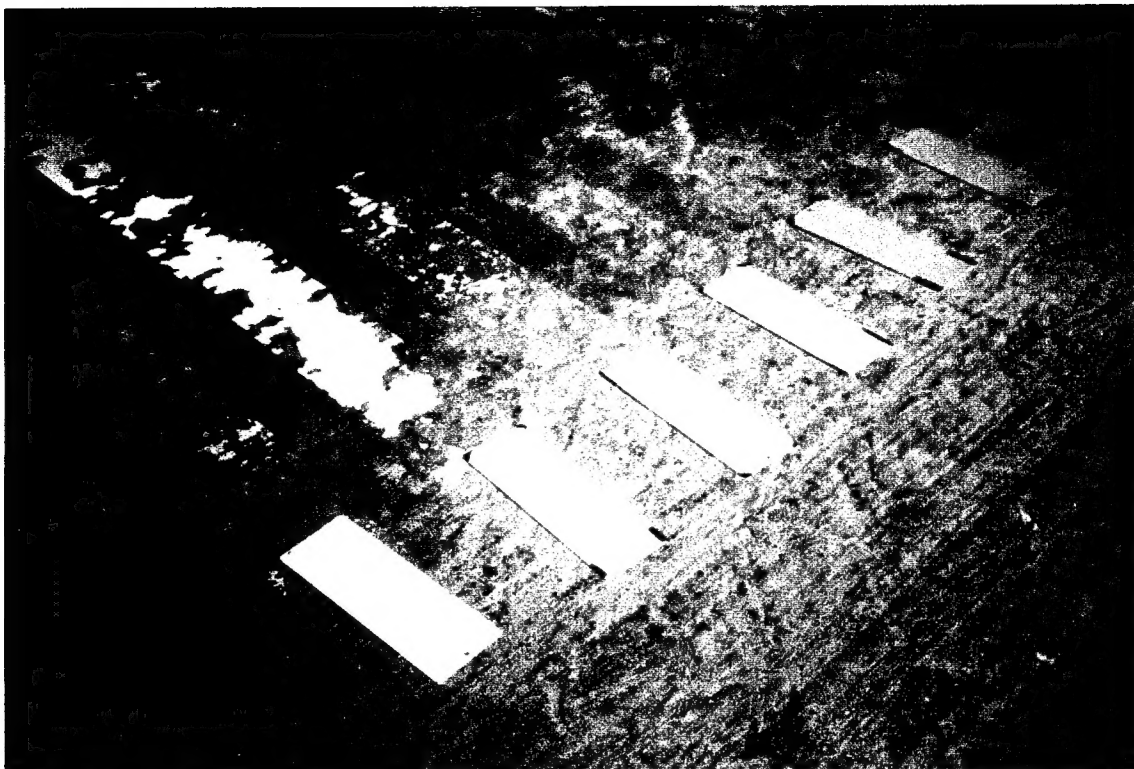
FIGURE A-30. WATER-BORNE NO. 1 TAXIWAY TEST STRIPE AFTER 1 YEAR - PITTSBURGH

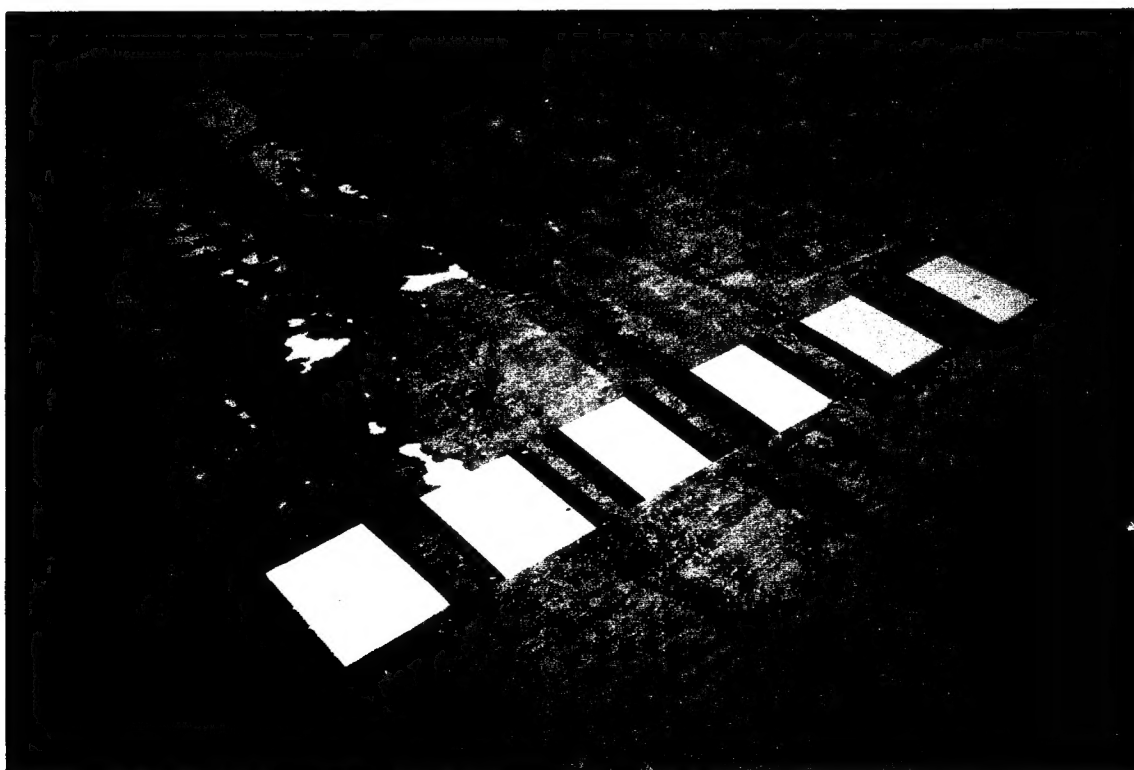
FIGURE A-31. WATER-BORNE NO. 2 TAXIWAY TEST STRIPE AFTER 1 YEAR - PITTSBURGH

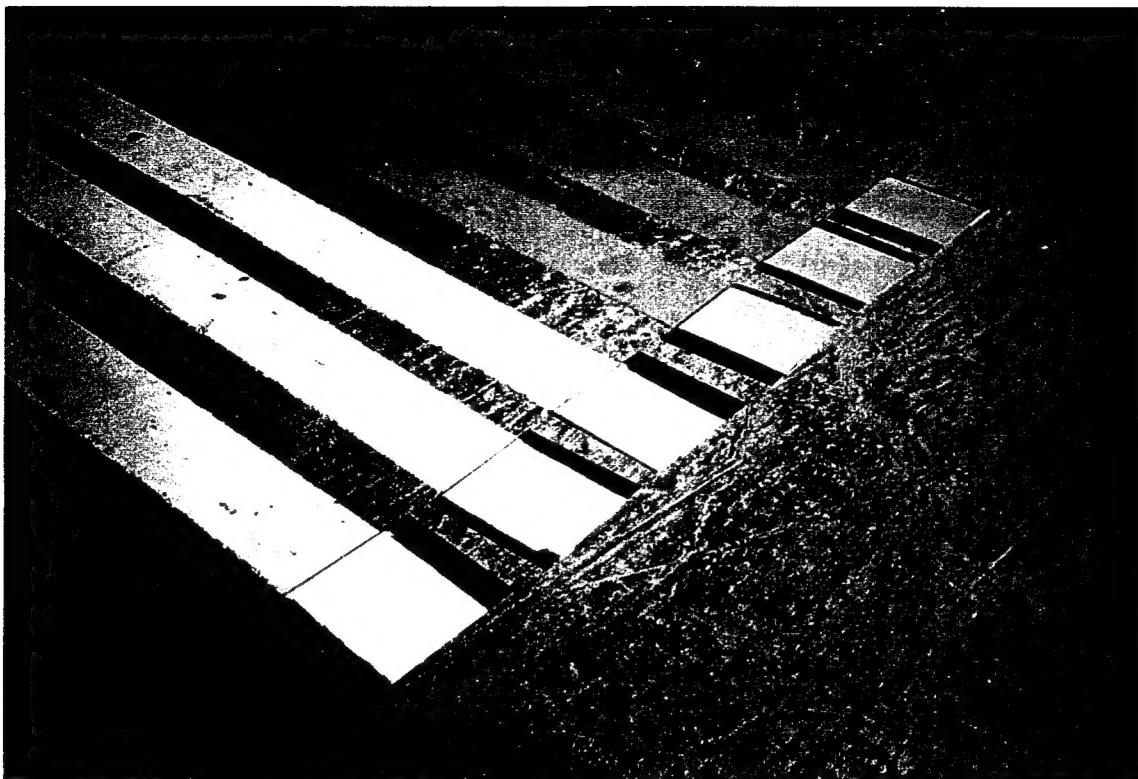
FIGURE A-32. METHACRYLIC RESIN TAXIWAY TEST STRIPE AFTER 1 YEAR - PITTSBURGH

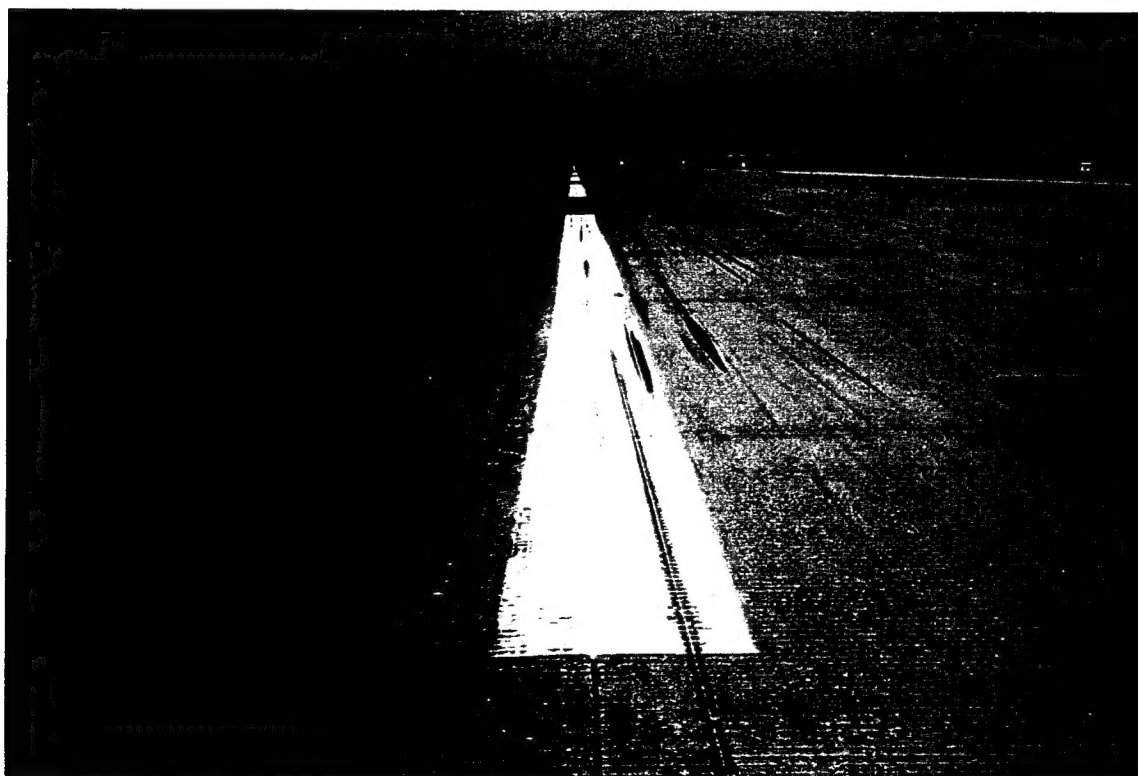
The overall condition of the test materials at the various locations at Pittsburgh airport varied considerably. At the completion of testing in June 1994, runway markings were in generally good condition. Very little rubber adhesion had occurred on the runway centerline test stripes. Significant yellowing was noted on the epoxy no. 1 material. The taxiway test stripes were significantly damaged, particularly the water-borne materials which suffered delamination from snow plow activity. Refer to figures A-26 through A-32 for photographs of the of the damaged test stripes. One of the epoxies also suffered delamination prior to completion of the test period at the Pittsburgh airport site. The methacrylic resin provided excellent performance in all criteria throughout the test period. The epoxy no. 2 performed very well also, with the exception of friction readings.

FIGURE A-33. RUNWAY TEST STRIPE AFTER 1 YEAR - PITTSBURGH
